Report Number **BTC 13269F**

A FIRE RESISTANCE TEST ON A GANG-NAIL SYSTEMS
LOADBEARING FLOOR, INCORPORATING
ECOJOISTS PROTECTED BY A DOUBLE LAYER
OF 12.5mm GYPROC FIRELINE BOARD,
CONDUCTED IN ACCORDANCE WITH
BS 476: PART 21: 1987: CLAUSE 7.

Test Date: 3rd March 2004

Customer: **Gang-Nail Systems Limited**

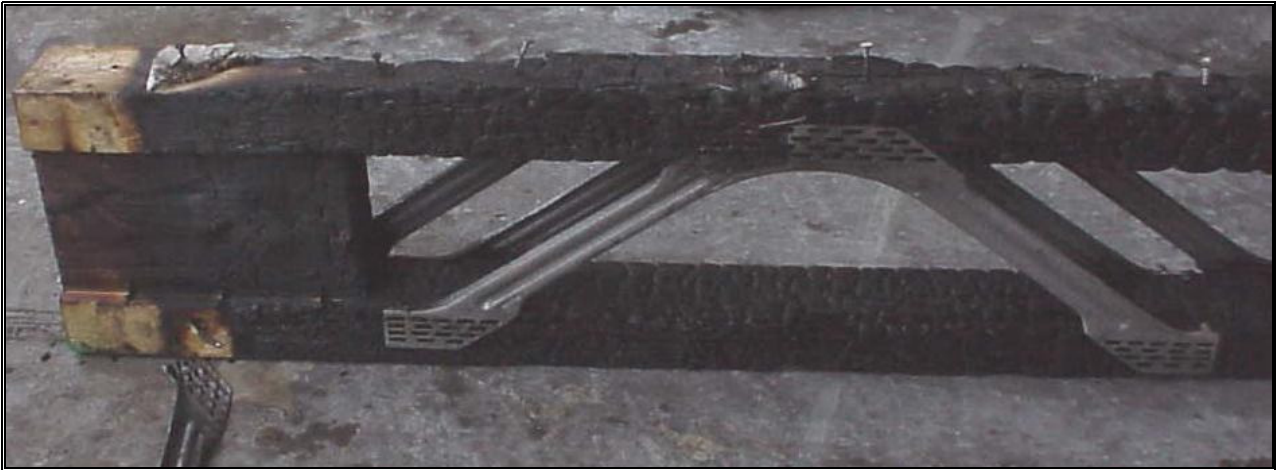
Time		Observations
hours	mins	
		<i>All observations refer to the exposed face unless otherwise stated.</i>
1	11	Poor visibility due to flaming. <i>Unexposed face</i> Whole floor visibly dropped.
1	12	<i>Unexposed face</i> Smoke issued from joints in chipboard walking surface.
1	13	<i>Unexposed face</i> LOAD BEARING CAPACITY FAILURE. The specimen failed to support the applied load. TEST TERMINATED.

Photograph 9. Joist after test, showing extent of damage (the other joists were in a worse condition than this one, but had fallen into the furnace).

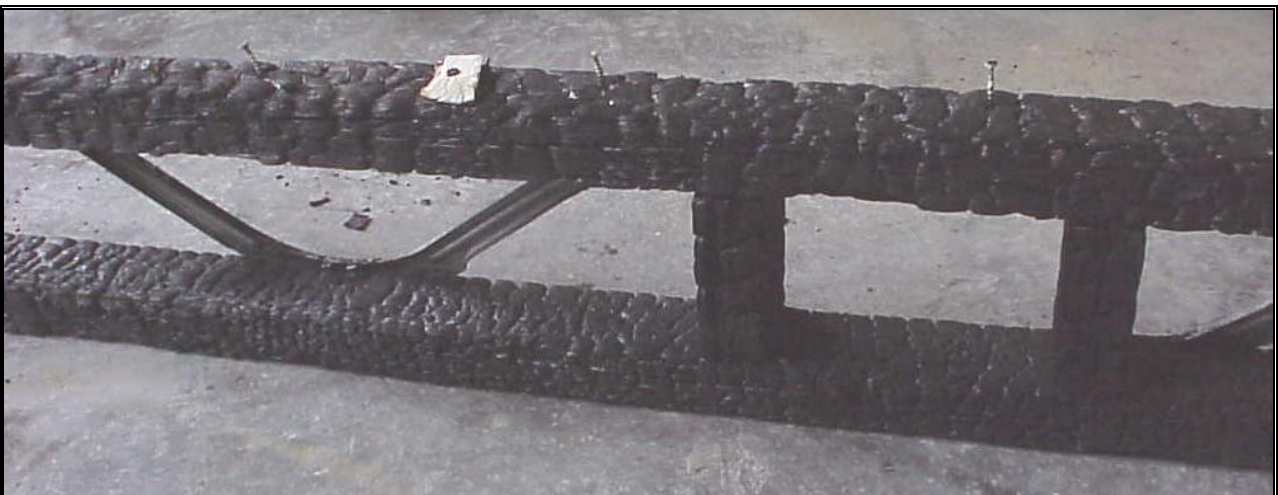
Photograph 10. The same joist as above.
